DAVIDE DI DOMENICO (\*) (\*\*) - LARA MAISTRELLA (\*)

## ABOUT THE PRESENCE OF TERMITES IN FLORENCE (¹)

Di Domenico D., Maistrello L. - About the presence of termites in Florence.

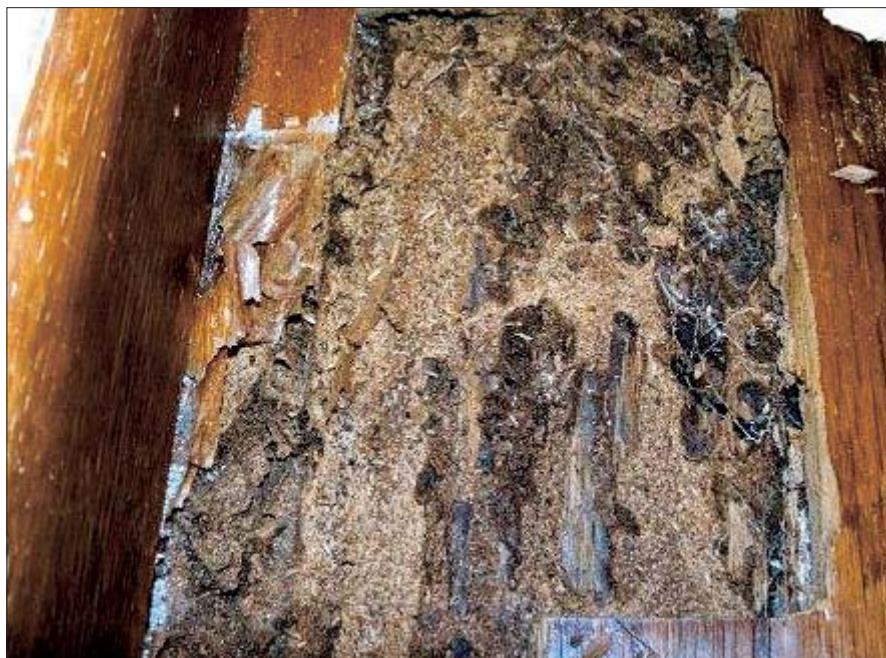
Fig. I – Strips of the parquet of the gym monitored in the study area, showing the typical signs of attack by subterranean termite. The wood appears lined with termite droppings, that being rich in moisture tend to clot and stick to the point where they are released. The droppings, mixed with soil and saliva, are used to construct the cells and galleries occupying the space freed by the wood consumption, forming the so-called "replacement wood".

The first detection of termites occurred inside a gym, located on the ground floor of one of the complex buildings, where, after the summer break (August 2013), users reported the failure of some parquet's strips and the presence of some "strange, white ants" inside the strips. The site's inspection revealed a heavy termite infestation in the wood flooring, where most of the parquet's strips appeared already seriously damaged.

At a first glance, the damaged wood collected from buildings and trees in the study area showed several internal galleries filled with fecal pellets, clear traces of "replacement wood" (Fig. I) and shelter tubes typical of subterranean termites belonging to the family Rhinotermitidae (MAISTRELLO *et al.*, 2011; MAISTRELLO, 2010). However, a more detailed analysis revealed also the presence of areas colonized by drywood termites (Kalotermitidae), easily recognizable by the presence of the characteristic prismatic fecal pellets. The subsequent analysis of the entomological samples collected inside the gym, led to identify the presence of the species *Reticulitermes lucifugus* and *Kalotermes flavicollis* (Fig. II and Fig. III; Tab. 1) (CHIAPPINI *et al.*, 2001; LIOTTA, 1991).

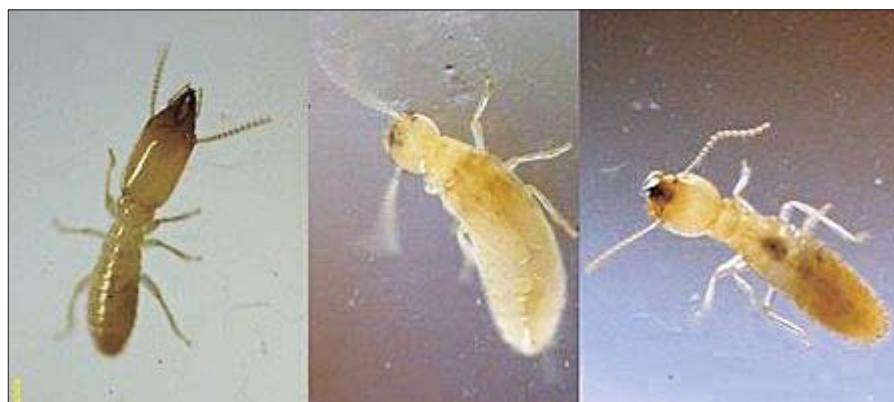
Fig. II – Sample of *R. lucifugus* collected in the gym. From left: soldier, nymph and worker.

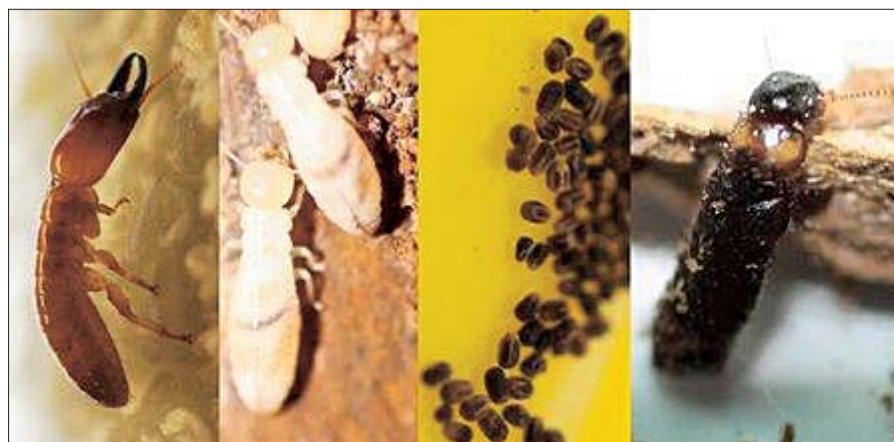
Fig. III – Sample of *K. flavicollis* collected in the gym. From left: soldier, nymph, typical prismatic faeces and royal.

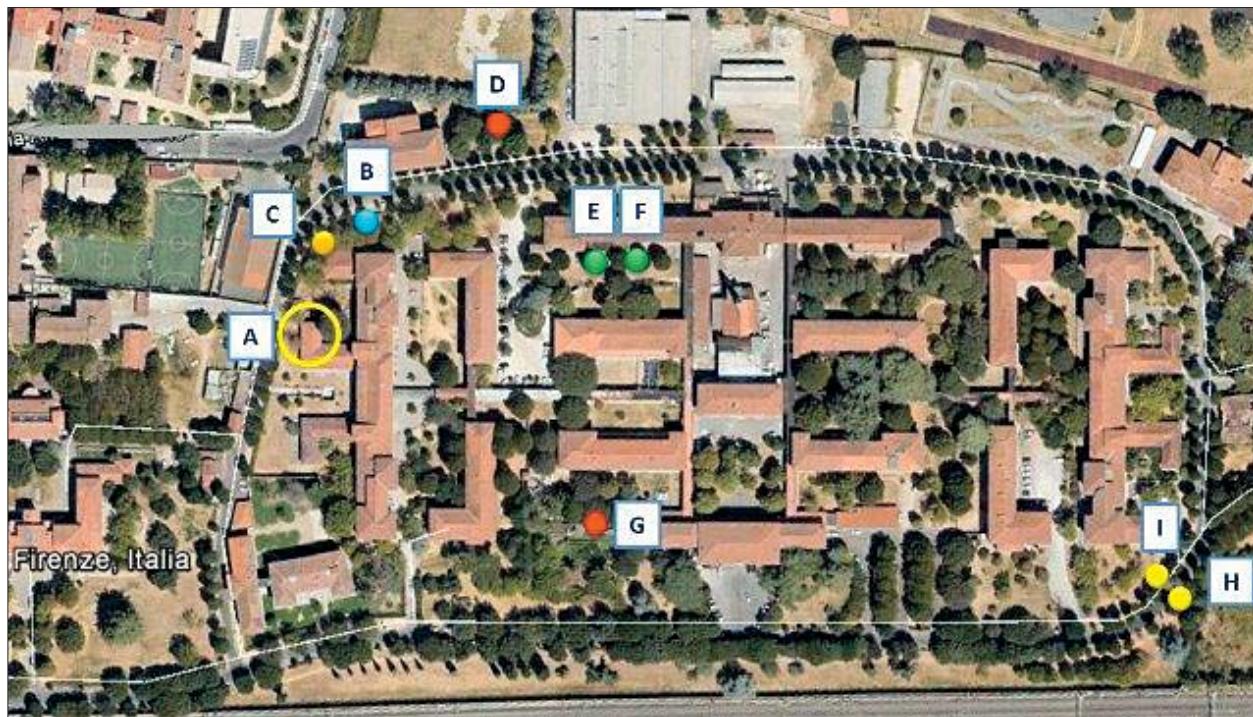
Fig. IV – Aerial view of the study area, showing the areas where active termite infestation was recorded during the monitoring program. Yellow circle= gym floor infested by *R. lucifugus* and *K. flavicollis*; Blue dot= tree stump infested by *R. lucifugus*; Yellow dot= tree stumps infested by *K. flavicollis*; Orange dot= necrosed roots of maple tree infested by *K. flavicollis*; Green dots= necrosed roots of linden trees infested by *K. flavicollis*; Red dot= collapsed trees.

Analyzing the outdoor area surrounding the gym (Fig. IV, Tab. 1), several colonies of both termite species were

detected, some located in tree stumps and other in the necrotic roots of some trees. Two episodes of collapsed tall trees were also reported. In particular: about 20 meters from the gym, a stump of maple was found completely infested by *R. lucifugus* and, after few days since the discovery of termites in the gym, a closely-located large plane tree collapsed, crashing during the night on the top of a bench, only by chance avoiding the occurrence of an accident to people. From the analysis of the trunk, the

plant appeared visibly carious and a conspicuous infestation by both wood boring beetles (Dynastidae) and *K. flavicollis* was detected. Although it is not possible to link the causes of the tree's collapse to termites, their potential role should not be neglected.

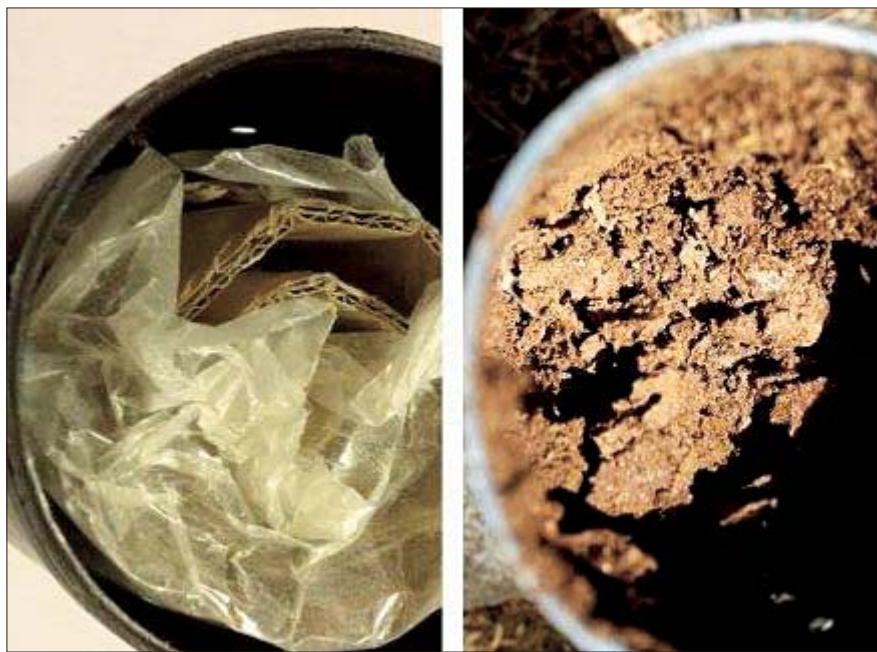
Fig. V – Appearance of a bait station before (left) and after (right) the termite attack. The feeding activity is clearly visible from the total transformation of the bait.

Considering the results from the baiting stations, in June 2014 termites' feeding activity was found in 2 stations between the gym and the maple tree stump (Fig. V). This finding was useful to plan the application of a low environmental impact control program, based on the foraging of the termite colony by cellulosic baits formulated with a specific IGR (Insect Growth Regulator) (BAGNERES *et al.*, 2008; EGER *et al.*, 2012; GAMBETTA *et al.*, 2000; SAJAP *et al.*, 2009).

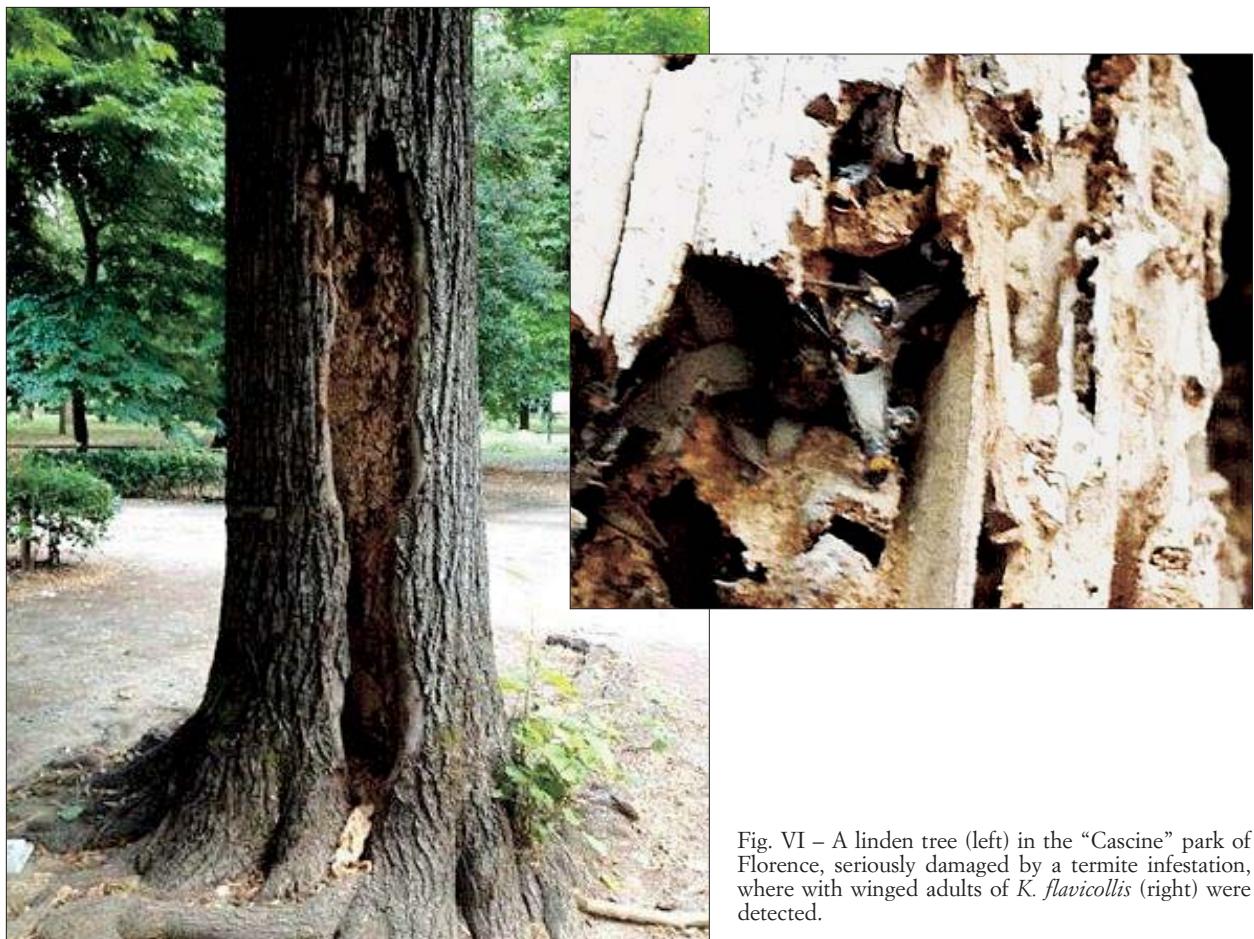
Fig. VI – A linden tree (left) in the “Cascine” park of Florence, seriously damaged by a termite infestation, where with winged adults of *K. flavigollis* (right) were detected.

The presence of termites in Florence was discovered also in other areas of the city, such as in the "Cascine" park and in the "Boboli" garden (LUCETTI *et al.*, 2014), where many trees showed clear infestation by *K. flavicollis* (Fig. VI).
